REDEVELOPMENT REPORT

A Housing And Urban Development Slum & Blight Assessment

JUNE
2017

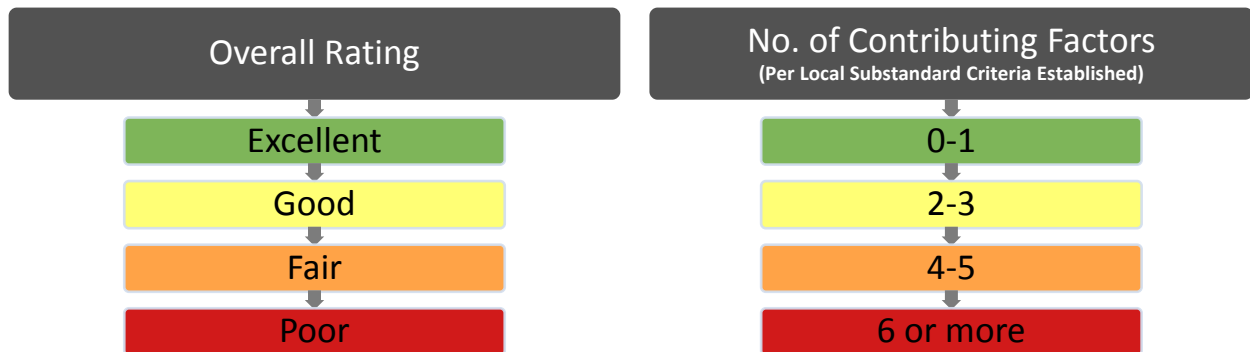
FIGURE 2 – SLUM AND BLIGHT RATING SCALE

condition. A numeric rating system was established to delineate the overall rating for each property. The scale shown in **Figure 2** was used.

Properties falling within the fair or poor rating scale qualify for slum and blight, per local definition.

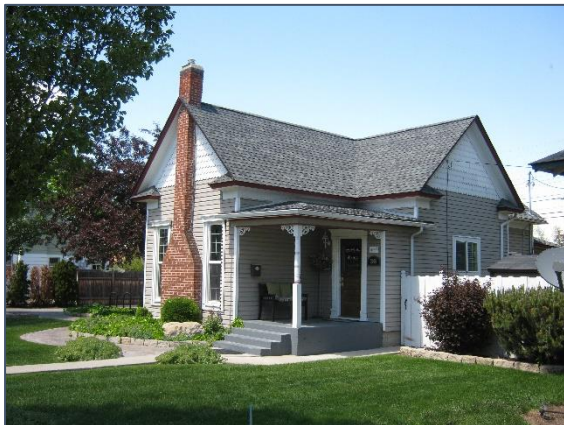
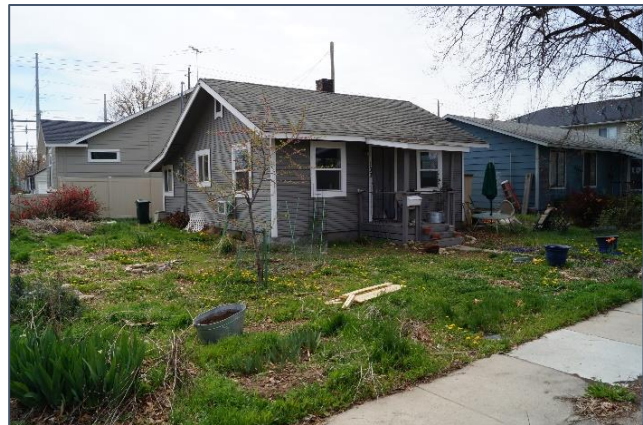
Residential land uses occur throughout the study area, primarily concentrated south of the railroad tracks and east of Meridian Road. While this area is clearly defined by its age and location, it also provides great potential. Of the properties inspected, 57.5 percent had structures 50 years or older, five of which are designated historic through the National Register of Historic Places (NRHP). Several of the structures contribute to the slum and blight of the area because of their age, but also due to sustained deferred maintenance and inadequate surrounding infrastructure. **Figure 5** shows that many of the older properties have façade-related contributing factors. **Figure 6** shows properties with neglected landscaping/property. The examples below depict actual field photos of properties within the study area that provide an illustration of the existing conditions within the residential neighborhoods.
